Planning Application for the Aylesbury Estate Regeneration

Plot 18 Reserved Matters Application

# Arboricultural Impact Assessment

**Aylesbury Estate, Plot 18, Southwark, London**

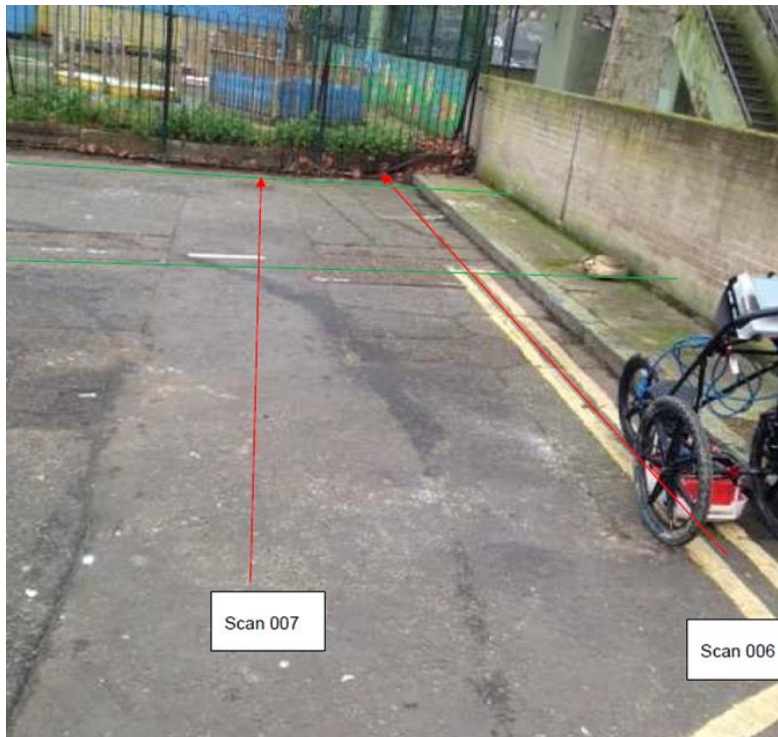
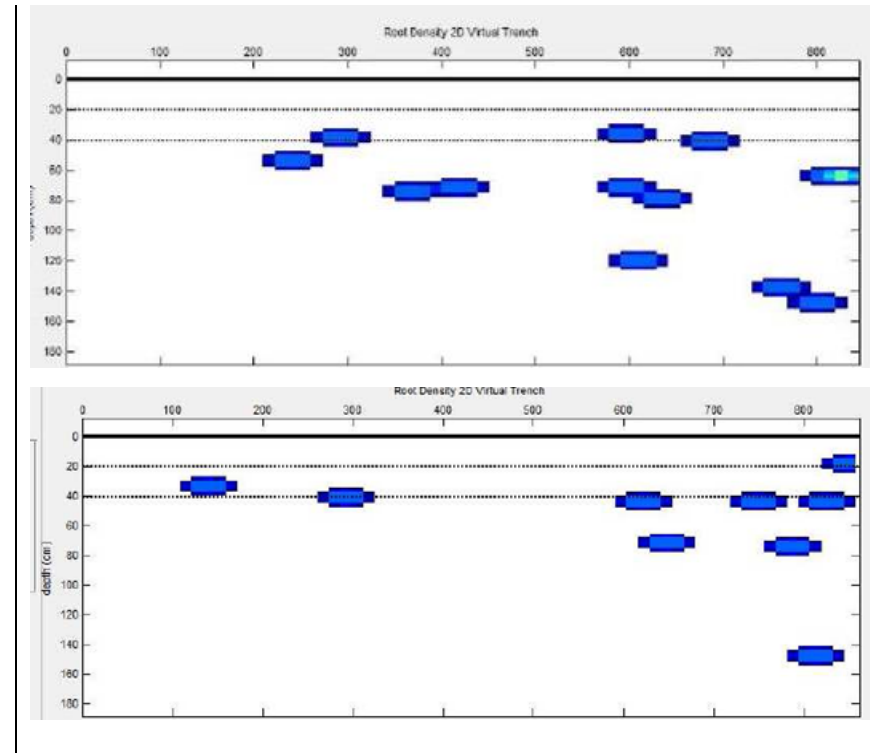
Fig 2 – T293 & T294 are to the right of the wall (left image). The radar scan showed a reduction in rooting within 3m of the trees.

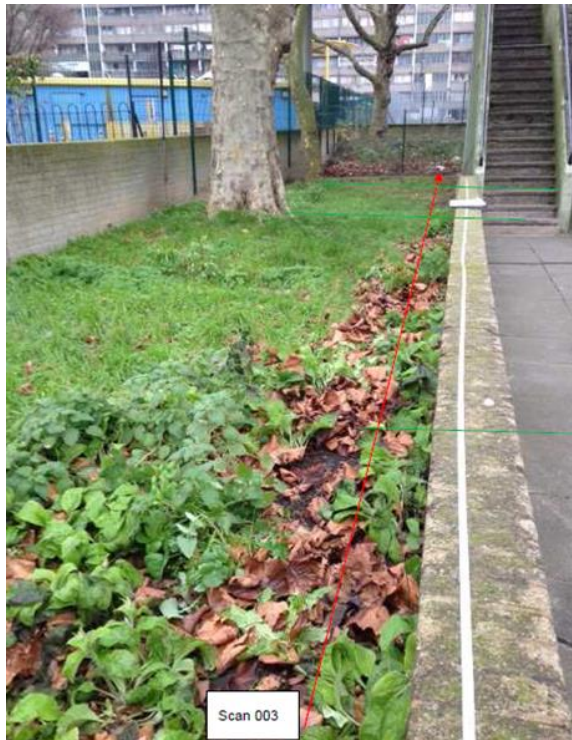
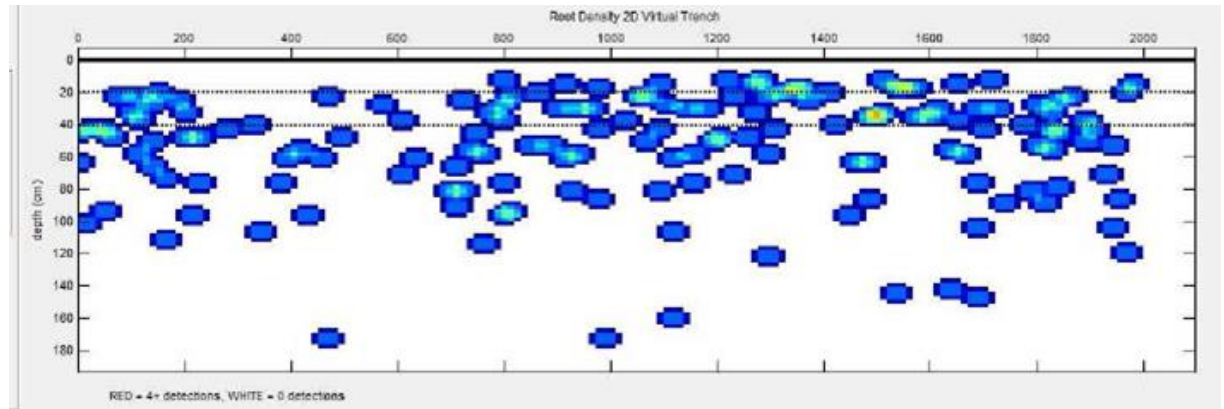
**Fig 3 – By contrast scan lines within the planter areas showed significantly higher level of tree roots. This reinforces the need for their protection during all site works (demolition and construction)**

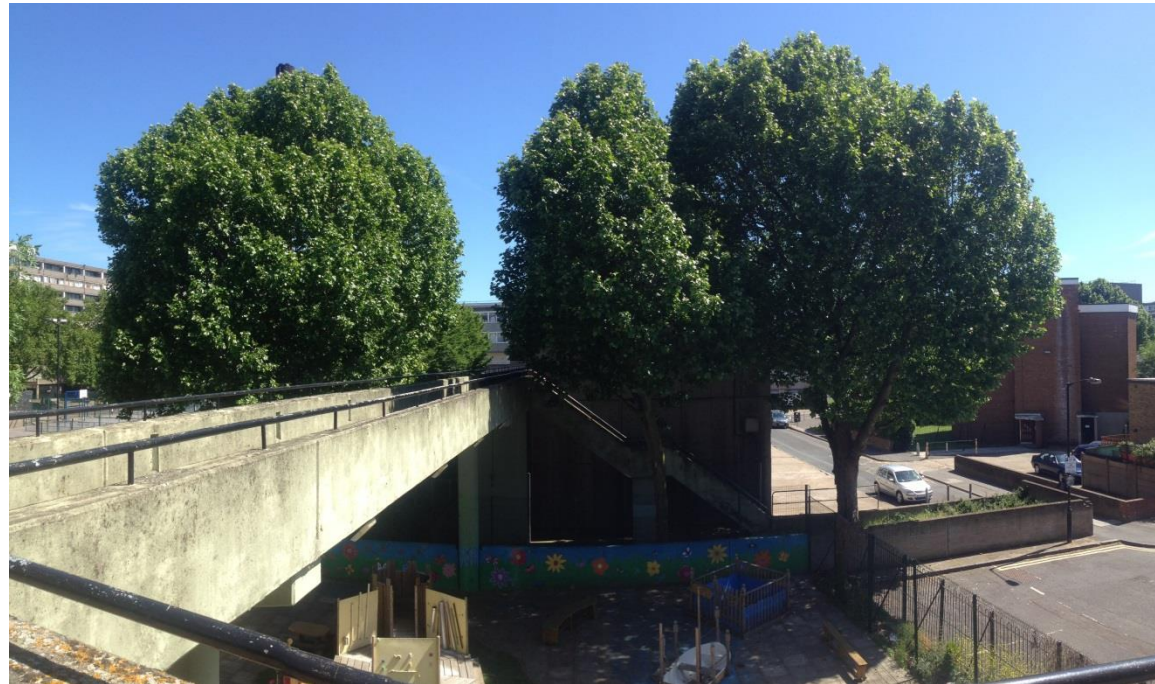
**Fig 5 – T295 (left), T294 (center) and T293 (right). These trees have been the subject of cyclical pruning in the past and some formative/reduction work is likely following the development. This will be kept under review**

5.8.1 The nature of the proposal is such that there should be no shading issues associated with retained trees. However, some cyclical pruning of tree canopies may be required to effectively reshape the trees following the development and reflect their previous pruning (reduction) regime.

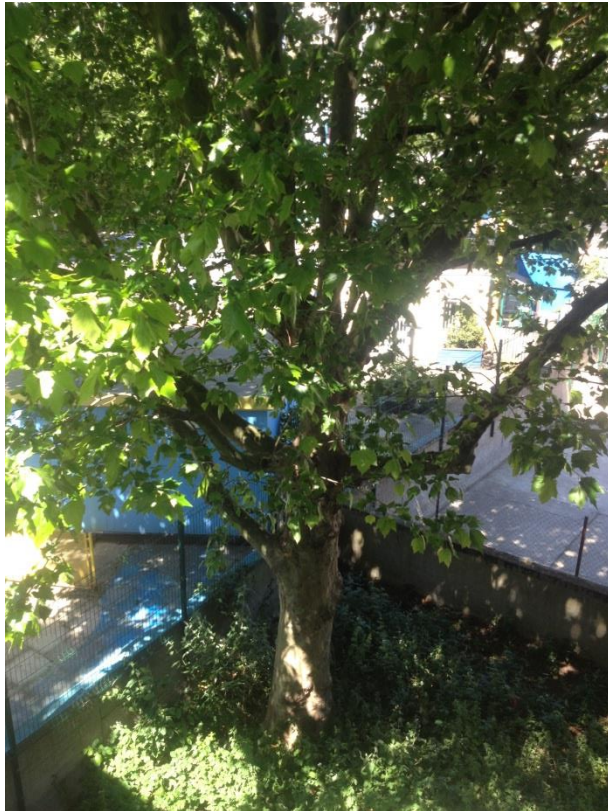
**Image 2** – Shuttering and fencing to secure existing ‘soft’ ground areas where tree root radar work shows significant rooting

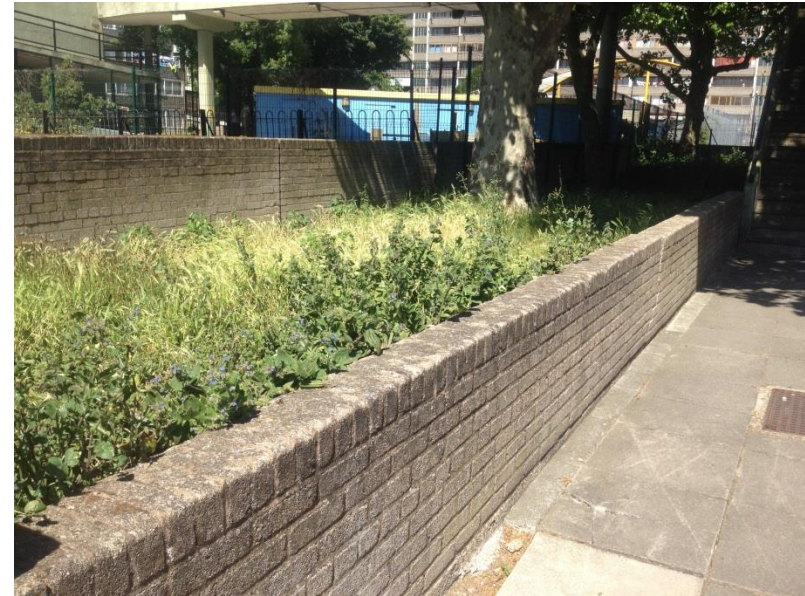
**Image 3** – Shuttering and fencing to secure existing ‘soft’ ground areas where tree root radar work shows significant rooting
